## Condition Report

*Staff Quarters – House Andre Olivier Durbanville Quadriplegic Centre*  
*Prepared on 7 April 2026*

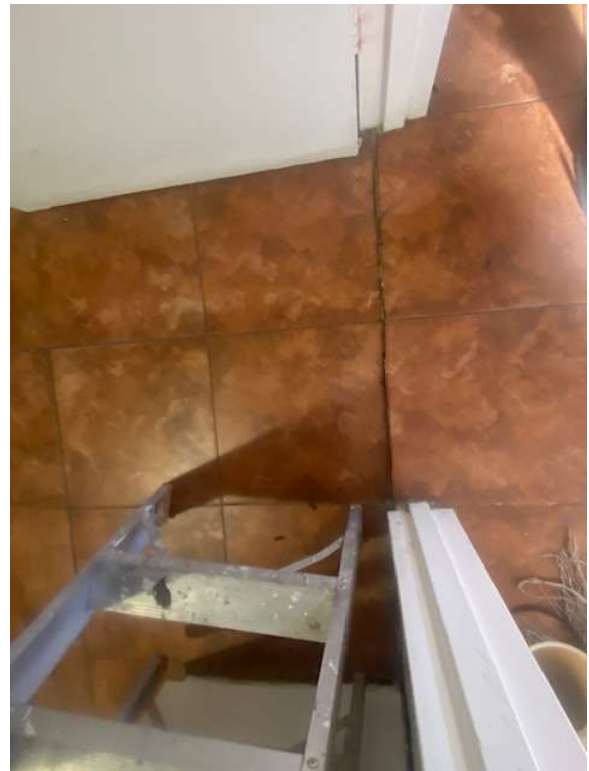
**Figure 2** - Visible floor cracking extending across the room, suggesting ongoing movement within the slab.

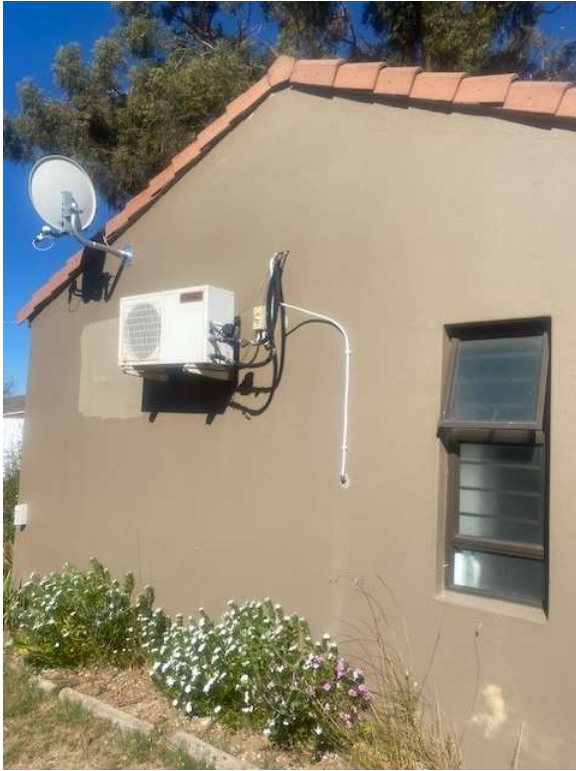
**Figure 3** - Localized plaster damage and cracking at low level due to slab movement.

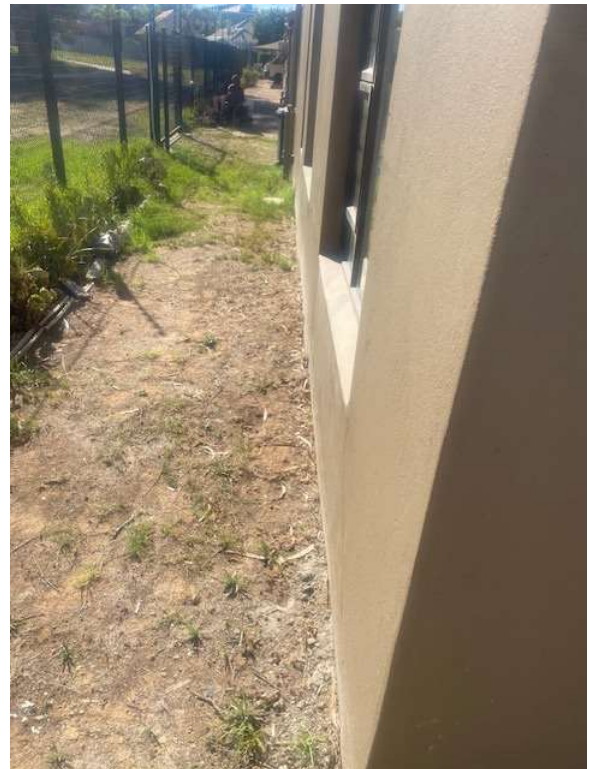
**Figure 8** - Wall-to-floor junction failure showing detachment of finishes due to movement.

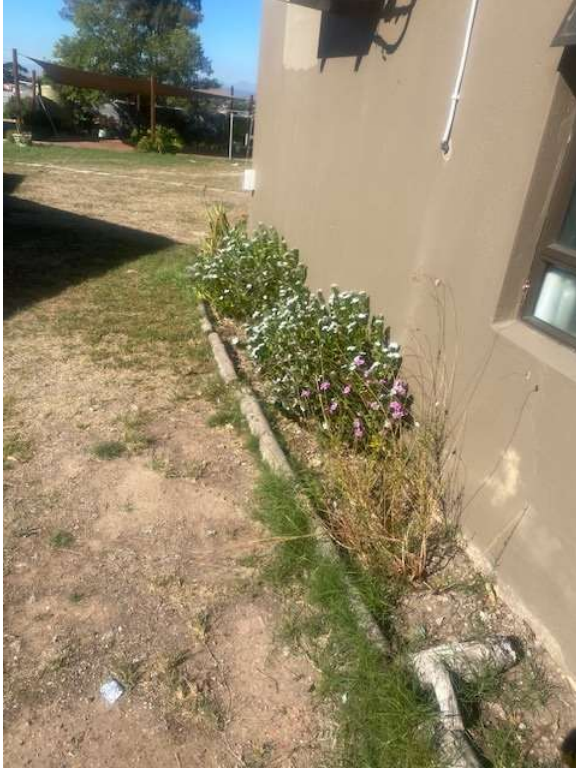
**Figure 9** - Minor cracking to wall surface consistent with secondary movement effects.

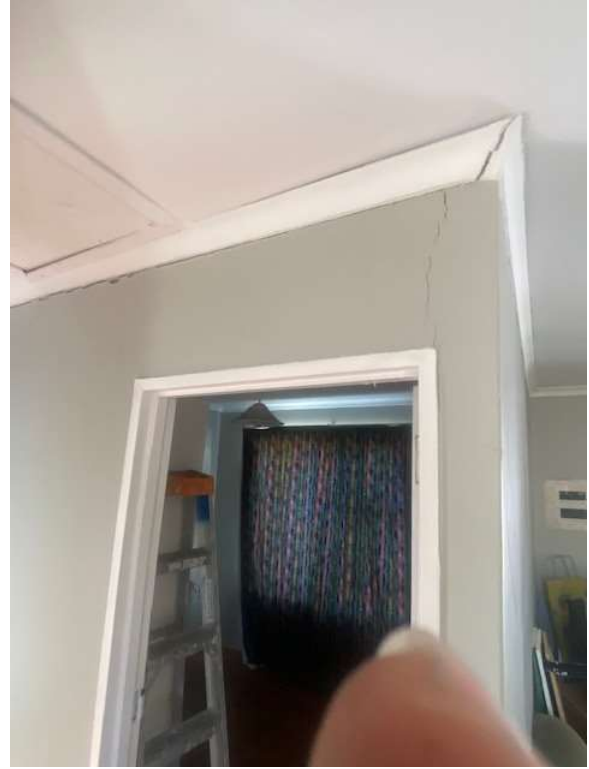
**Figure 10** - General view of affected area highlighting extent of settlement-related damage.

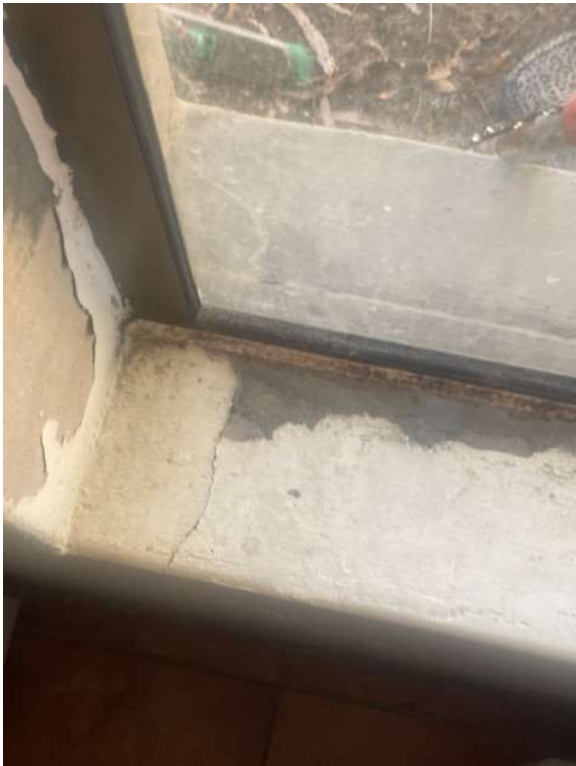
**Figure 11** - Cracking to internal wall consistent with settlement-induced stress and displacement.

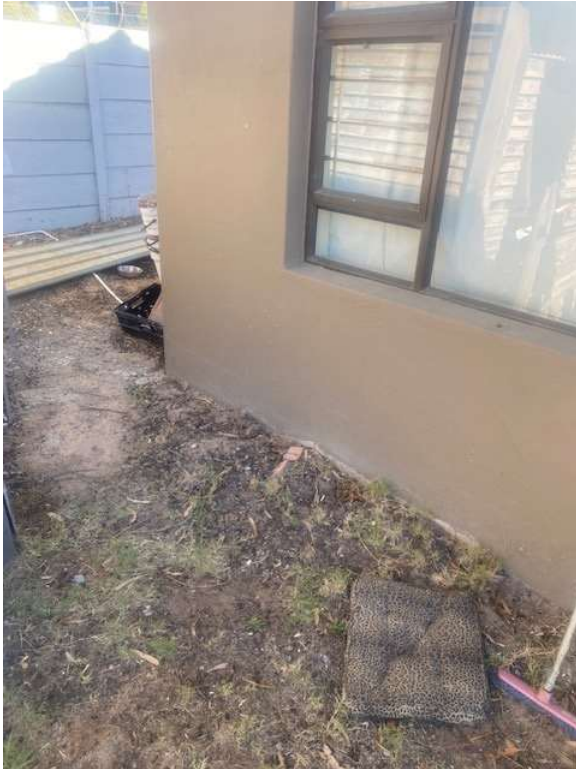
**Figure 13** - Diagonal wall cracking typical of differential settlement near openings.
